ASHOKAN DAM

ULSTER COUNTY, NEW YORK

PHASE I INSPECTION REPORT  
NATIONAL FIRE SAFETY PROGRAM

PHASE I INSPECTION REPORT  
NATIONAL DAM SAFETY PROGRAM  
ASHOKAN RESERVOIR, INVENTORY NO. 41  
HUDSON RIVER BASIN  
ULSTER COUNTY, NEW YORK

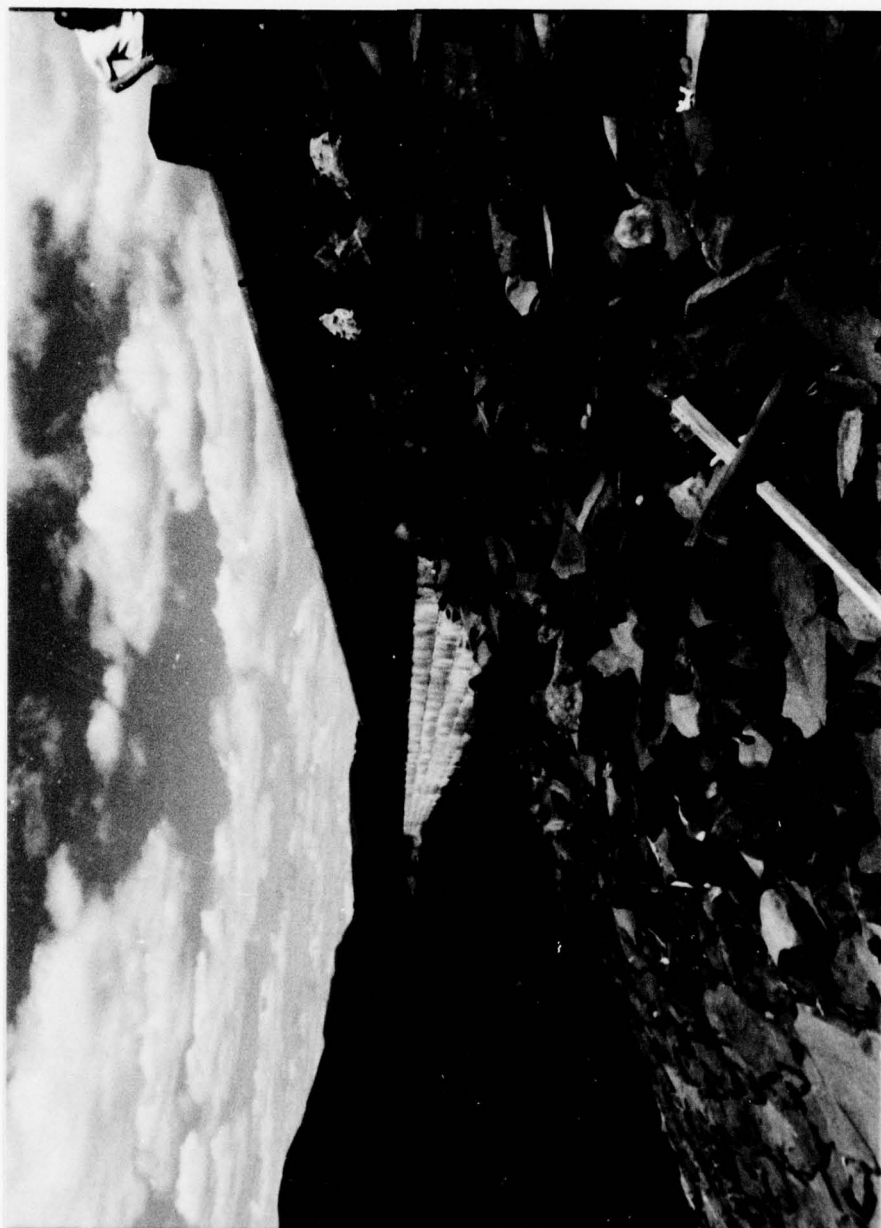
GENERAL OVERVIEW OF OLIVE BRIDGE MASONRY DAM

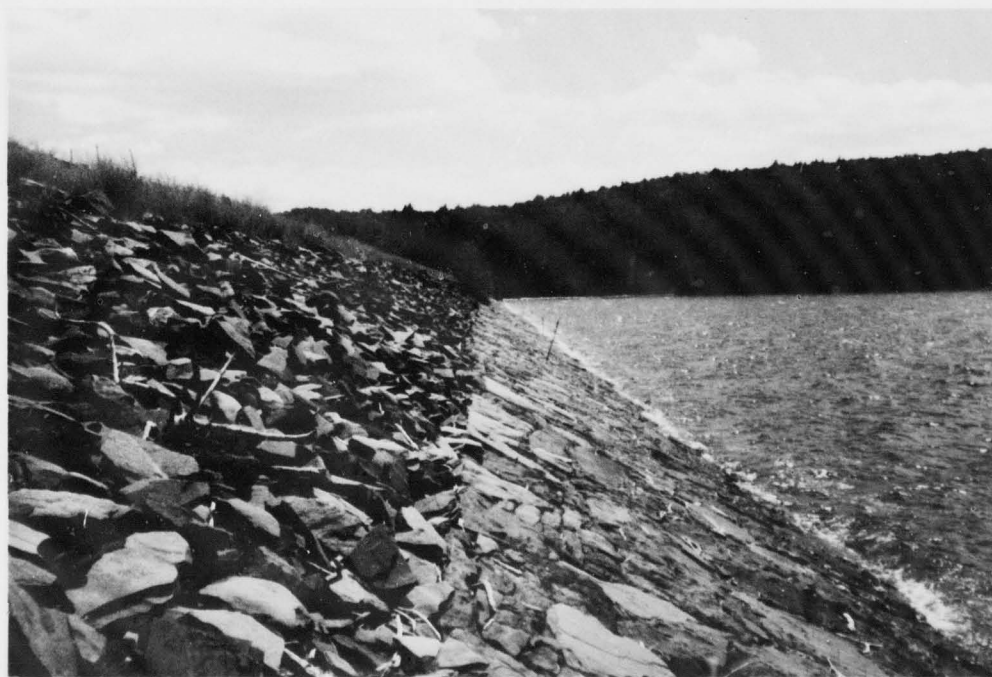
UPSTREAM SLOPE OF SOUTH EMBANKMENT OF DAM.(LOOKING SOUTH)

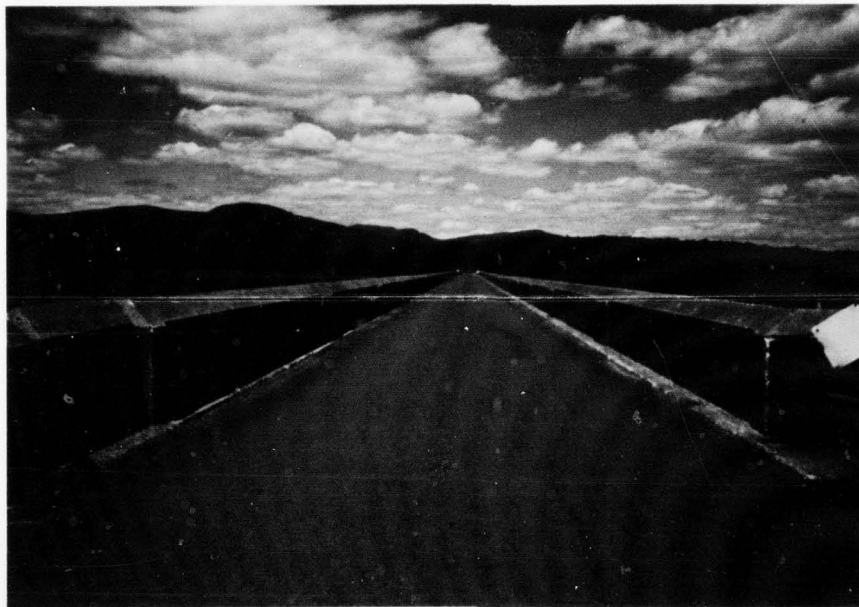
CREST OF OLIVE BRIDGE MASONRY DAM

c. The concrete parapet on the top of the masonry portion of the main dam should be repaired. Also a snow clearing procedure should be developed so that snow and ice mixed with de-icing salts is not disposed of on the downstream coping near the top of the dam.

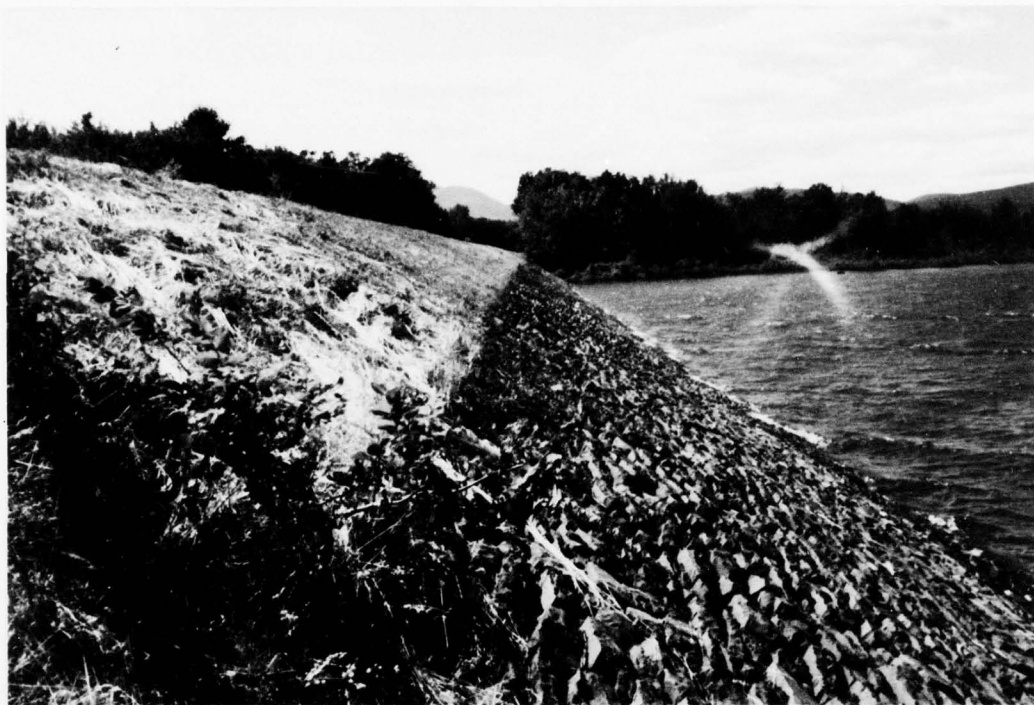
VIEW OF UPSTREAM SLOPE OF EAST DIKE. (LOOKING WEST)

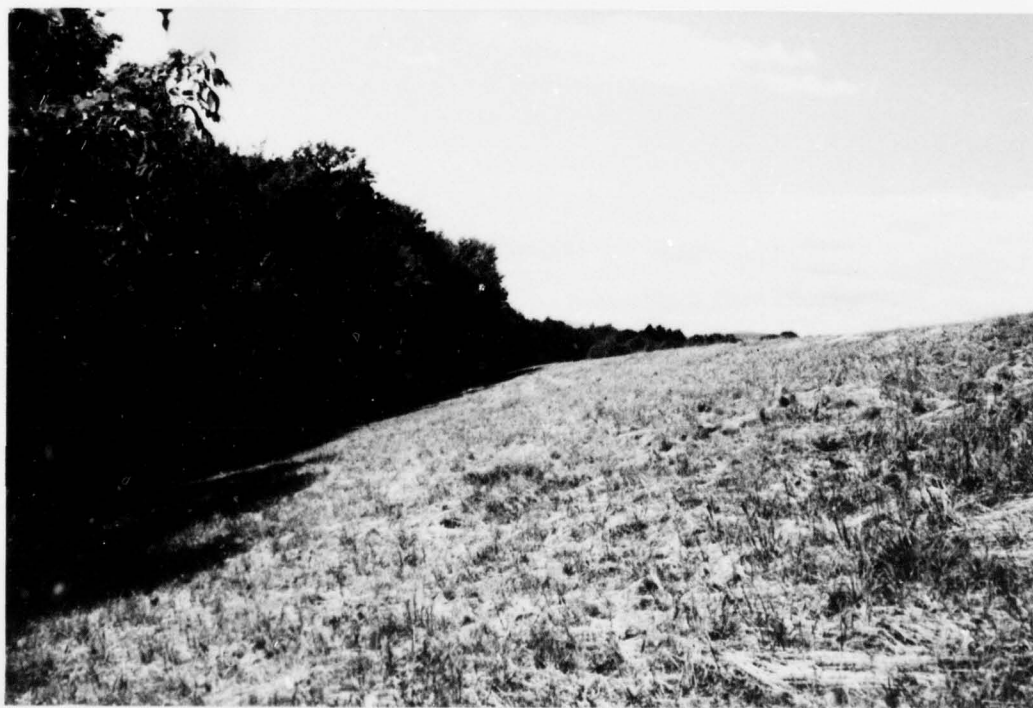
VIEW OF DOWNSTREAM SLOPE OF EAST DIKE. (LOOKING WEST)

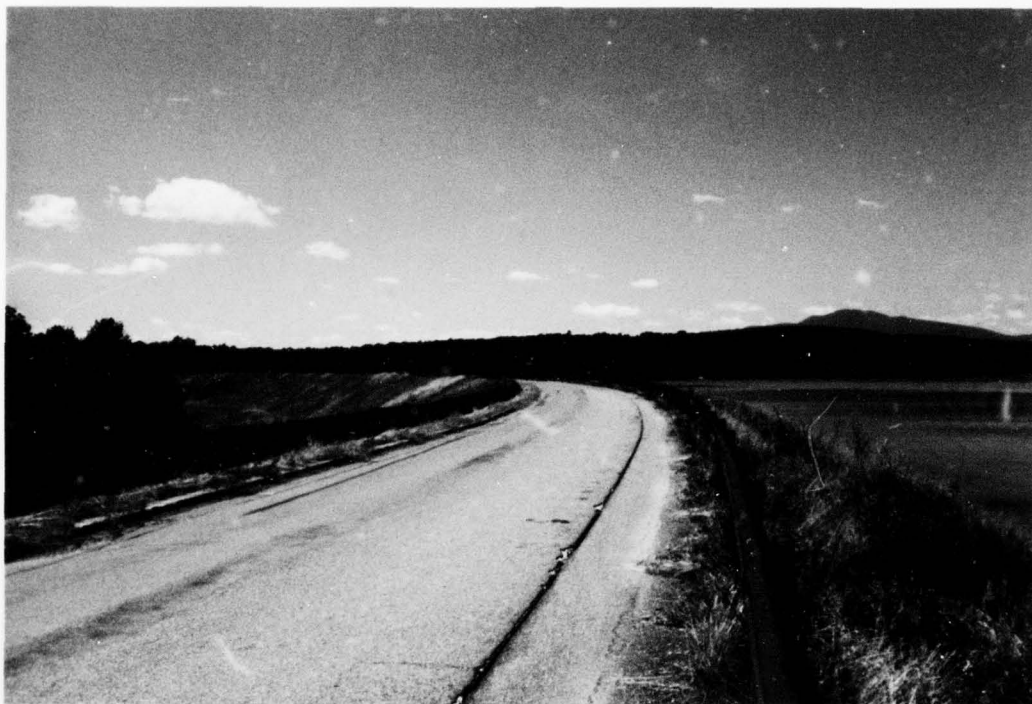
VIEW OF WEST HURLEY DIKE. (LOOKING SOUTH)

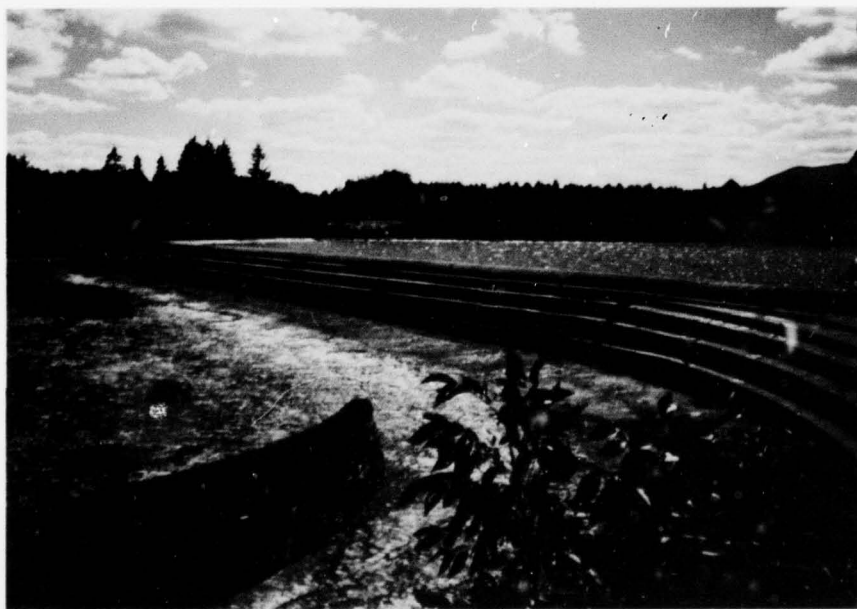
DOWNSTREAM FACE OF SPILLWAY AND FLOOR CHANNEL  
AND MASONRY WALL. (LOOKING SOUTH)

THE ORIGINAL CYCLOPEAN MASONRY SPILLWAY (WEIR)  
WAS REHABILITATED BY APPLYING A GUNITE SURFACING TO  
THE STRUCTURE. THERE WERE SOME MINOR LEAKS AND  
SEEPAGE FROM JOINTS OF THE WEIR. HOLES FOR FLASHBOARDS  
WERE NOT RESTORED TO THE CREST SURFACE. THERE WERE  
SOME LOOSE STONES IN THE FLOOR.
